TCF-S Firmware Upgrade

TCF-S / TCF-S3 Temperature Compensating Focusers

#17565 – TCF-S Firmware Upgrade

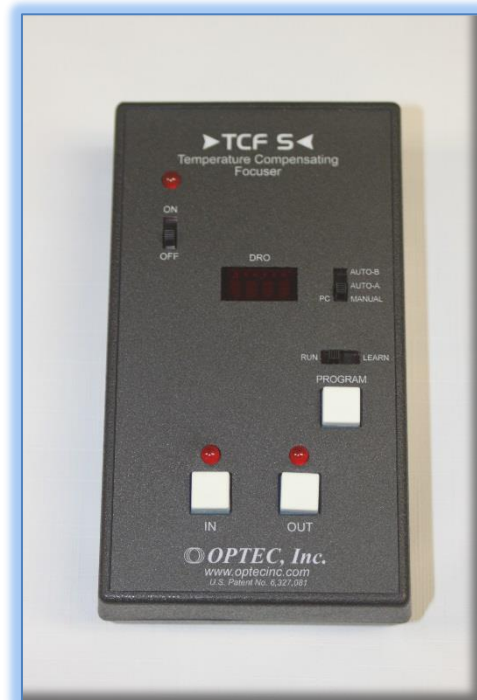
TCF-S Hand Controller

The original TCF-S focusers included an external hand controller with red digital read-out (DRO) display, IN and OUT pushbuttons, a Program button and associated RUN/LEARN slide switch, and a 3-position slide switch for PC/MANUAL control and closed-loop AUTO A or AUTO B temperature compensation modes. Connections at the top of the hand controller box include a 12VDC power input (2.5x5.5mm) connector, 6-pin RJ12 connector for serial communications, and an 8-pin RJ45 socket for connection to the TCF-S focuser body. Stepper control voltages and return temperature data are passed along an 8-wire Control Cable through the RJ45 connector to the DB9 connector on the focuser motor housing.

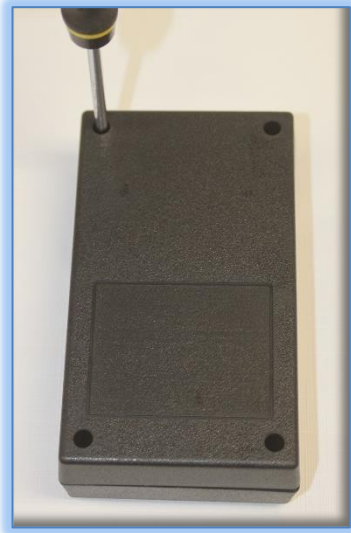
Step 2 – Remove Board

A Phillips-head screw inside each foot hole needs to be removed. Use a small Phillips-head screw driver to remove the back cover. Next, unscrew the four slotted or Phillips head screws holding the board in place. Flip the board over and keep the screws in a safe place.

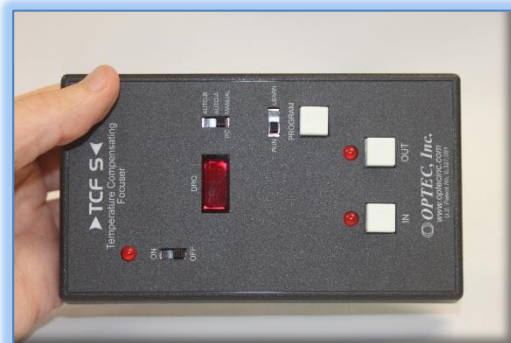
Step 6 – Re-install Board

Re-install the board into the front cover being certain the LED's and buttons are lined up properly with the holes in the front half of the control box. When you power up the hand control, the front display should show the new firmware version number.

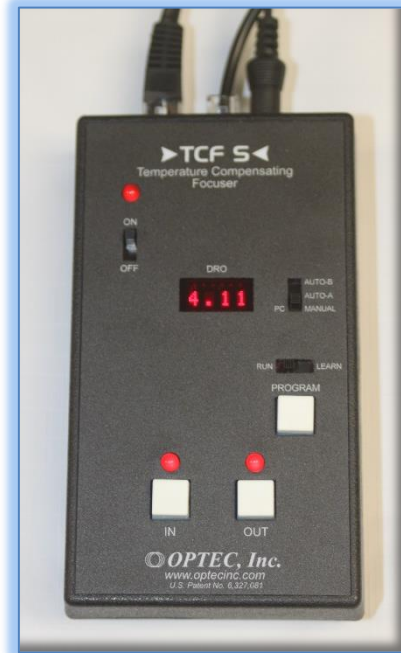
Step 8 – Install Software Drivers

Visit the [TCF-S Download Page](#) and download the latest TCF-S Control Software and ASCOM drivers.

Test the serial connection and ASCOM Local Server software to connect your favorite auto-focus software.
